Flood Investigation Report

Reference: 25042012/SO163LF
Daisy Dip

Location: Daisy Dip (Eastern section of the park)

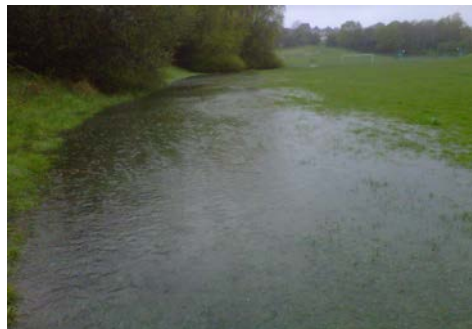
Identified source(s): Surface water runoff from surrounding areas during and following rainfall events (Photos 1 – 2).

Photo 1: Surface water flooding during a heavy rainfall event (25th April 2012) (Photo taken by resident)

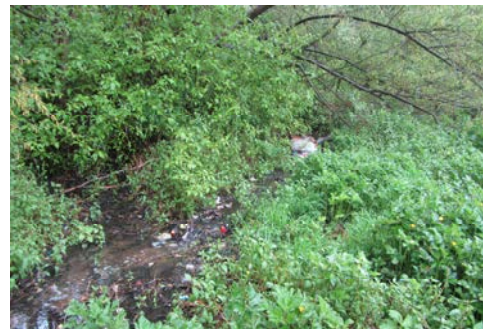
Photo 2: Surface water runoff during a moderate rainfall event (10th May 2012)

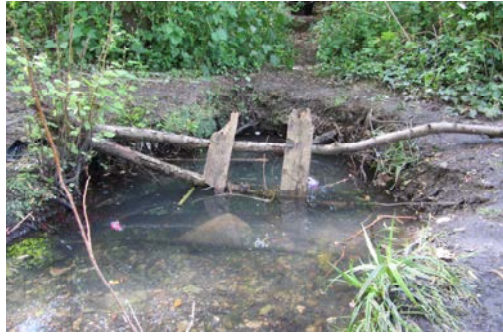
Cause/pathway: Damaged surface water sewer infrastructure (Figure 1, Photos 3 – 4)

Photo 3: Area with suspected damaged surface water sewer

Action/proposed action in response: Sewer crew (working on behalf of Southern Water) attended the site on 2nd June 2012. Once shown the problem they indicated that the surface water sewer and manhole covers were in need of civil intervention. Southern Water will ascertain, following further site visits, what they will do to remedy this issue.

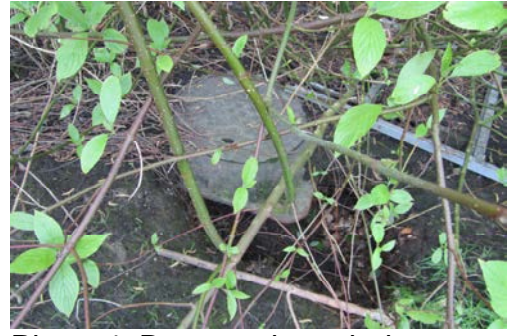
Photo 4: Damaged manhole

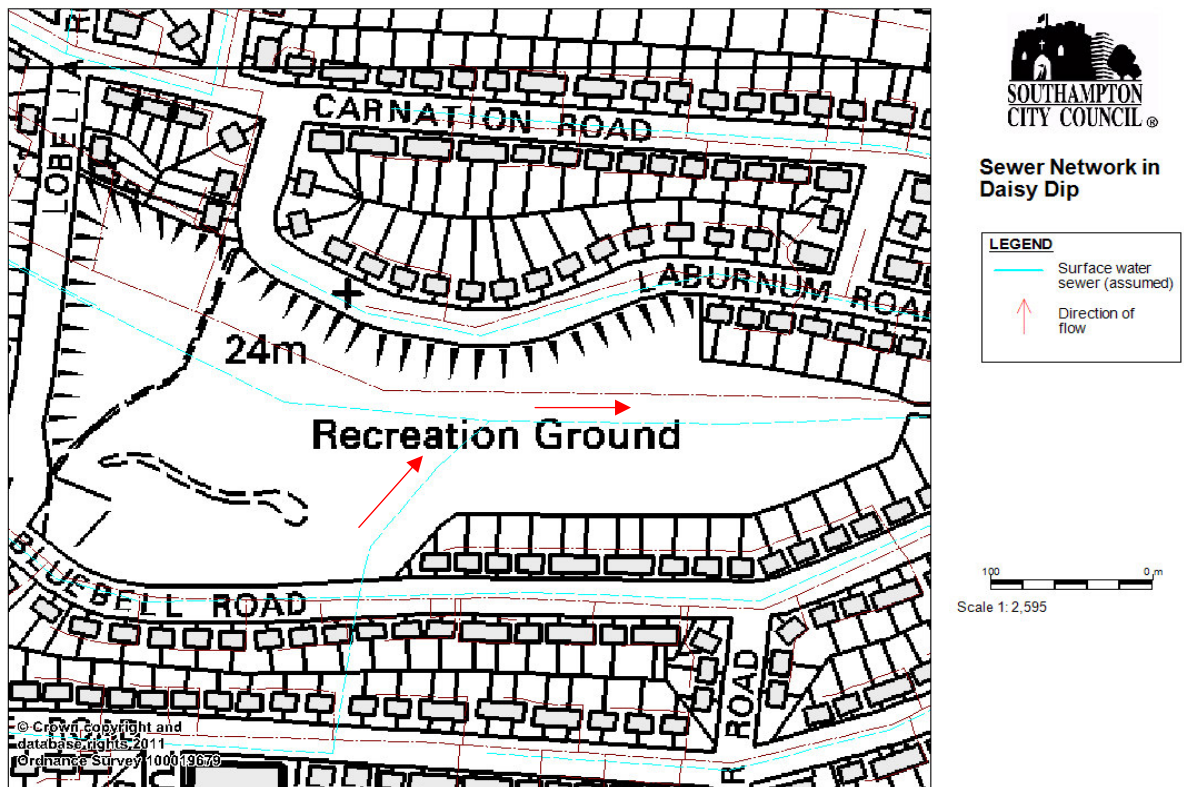
Figure 1: Surface Water Sewer Network (assumed) through Daisy Dip
