Asbestos Survey

**Admin Unit, REDBRIDGE TOWERS, CUCKMERE LANE,
SOUTHAMPTON**

Property Reference	2452100001	Date printed	18 February 2019
Plan No		Information last revised	30 January 2019
Construction Type	MILLER 1963	Inspection Duties	Property Manager

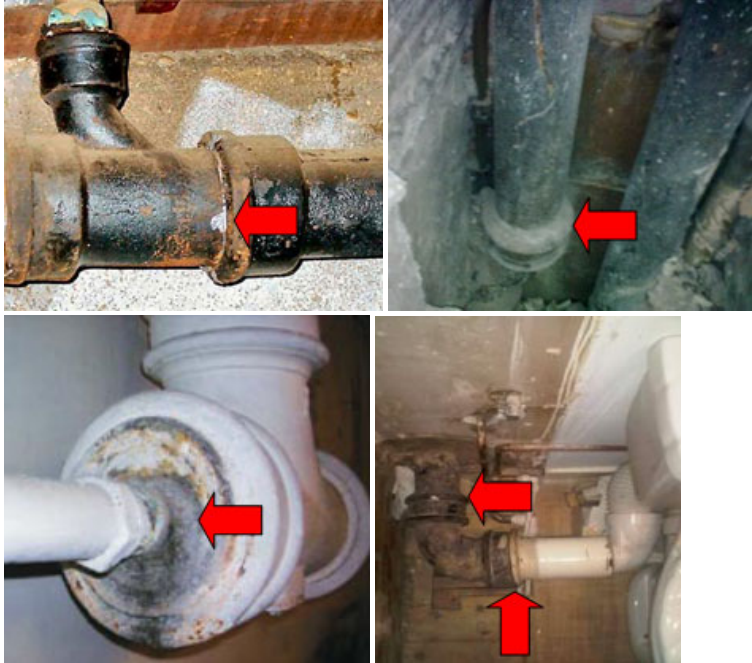
Location	Material Type	Sampled	Extent	Condition	Damage Risk	Surface Treatment	Asbestos Type	Asbestos Content	Risk Category
<p>Incident 286 of 286 Throughout Cast Iron Waste Pipe - Packing</p>	<p>Comments: Amosite and/or chrysotile may be present as packing around pipe connections e.g. with toilet. Any visible or potential packing material must be assessed prior to any likely disturbance, or the presence of asbestos must be assumed and managed accordingly. Work on this material is typically classified as notifiable non-licensed work. Please examine the example photographs below:-</p>
