14 East Street

Context

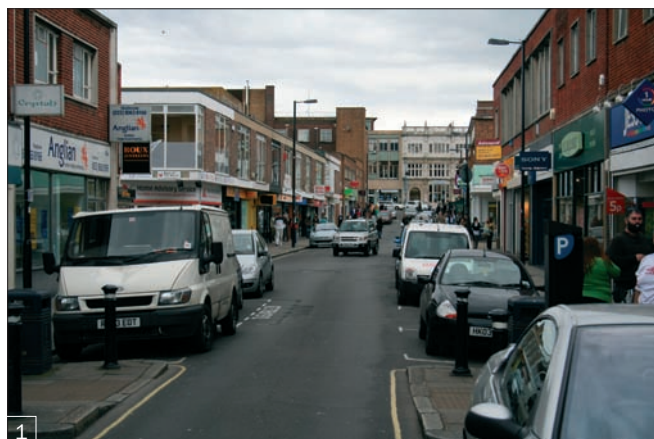
- 01 East Street looking west – modest two storey development
- 02 Capital House to the east with its striking external stair – a local landmark in East Street
- 03 Signage in East Street encouraging a sense of place separate from the main commercial core

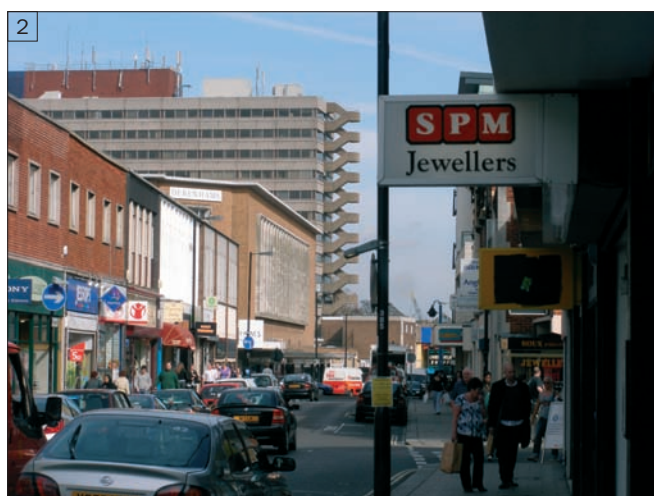
The low profile of East Street Shopping Centre allows view to dome beyond. The residential slab-block (twelve storeys) on the edge of the east end of the character area partially closes the view. The escape stairs to this slab-block form a strong skyline element. There is a good terminated view of the west end of the street by a well-detailed late nineteenth century bank building.
