Southampton City Council

City Characterisation Project

# PA07 St Mary's Road (Commercial core)

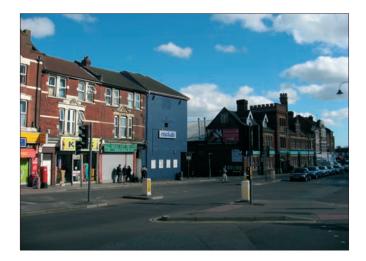
The former drill hall (seen with the crenellated tower) is a memorable building in the townscape

- This road has a high degree of architectural quality despite being in a very poor state of repair and with much alteration to ground floor shops and to windows.
- The former Drill Hall is a striking building in the street scene with its crenellated tower forming a strong central feature in the facade.

Much needed improvements to the design and material quality for shopfronts and signage.
