#### **Southampton City Council**

City Characterisation Project

## 15 Back of the Walls and Canal Walk

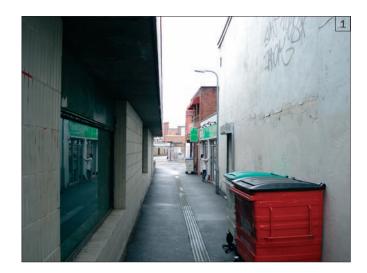
- 01 View from East Street looking south along Back of the Walls
- 02 Bonded Warehouse, Back of the Walls
- **03** Vacant and neglected sites within the character area
