Asbestos Survey

Admin Unit, ALBION TOWERS, GOLDEN GROVE, SOUTHAMPTON

Property Reference	3118100005	Date printed	18 February 2019
Plan No		Information last revised	10 December 2018
Construction Type		Inspection Duties	Environmental Health Service

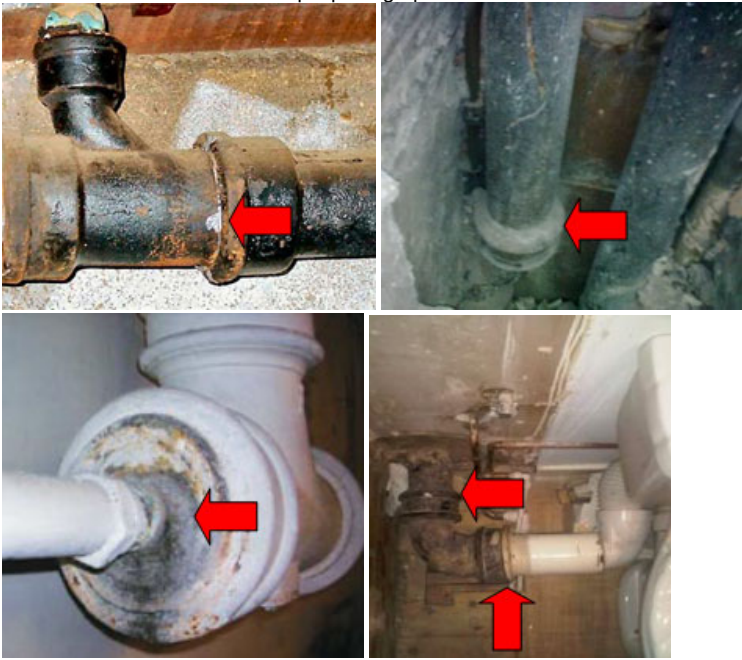
Location	Material Type	Sampled	Extent	Condition	Damage Risk	Surface Treatment	Asbestos Type	Asbestos Content	Risk Category
Bitumen Adhesive	Comments: Bitumen adhesive to concrete ceiling and polystyrene board.								
Incident 437 of 438 External - Undercroft Adhesive	NAD	Yes					Non-Asbestos		
Comments: Adhesive to backs of polystyrene ceiling tiles. 2 samples taken.									
Incident 438 of 438 Throughout Cast Iron Waste Pipe - Packing	Rope	Presumed	0.3 m	Good	Medium	Untreated	Amphibole	16 - 30%	C
	<p>Comments: Amosite and/or chrysotile may be present as packing around pipe connections e.g. with toilet. Any visible or potential packing material must be assessed prior to any likely disturbance, or the presence of asbestos must be assumed and managed accordingly. Work on this material is typically classified as notifiable non-licensed work. Please examine the example photographs below:-</p>
