City Characterisation Project

11 West Gate, Town Walls and the Castle

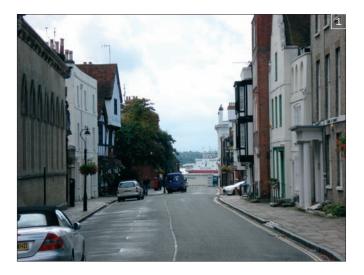
01 Important view south along Bugle Street to the waterfront02 The Town Walls seen from the Western Esplanade03 New development sympathetic to the scale of the old town

There is an important view looking south along Bugle Street which picks up on the waterfront activity and further views of the waterfront from the mound adjacent to the Maritime Museum.

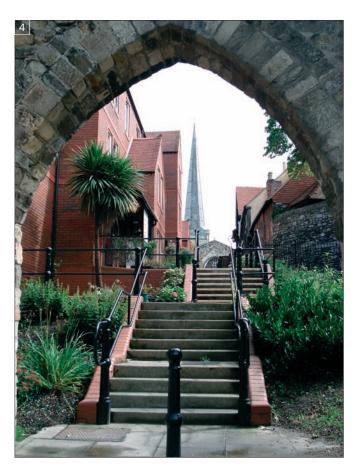
04 View to the Spire of St Michaels from Western Esplanade

The twelve storey slab block (Castle House) breaks the vertical and horizontal scale, and, whilst it is of some note historically, it has a negative landmark effect in the streetscene. The major positive landmark is the spire of St Michaels Church, which is glimpsed from a number of vantage points in the city.
