PA07 St Mary's Road (Commercial core)**Context**

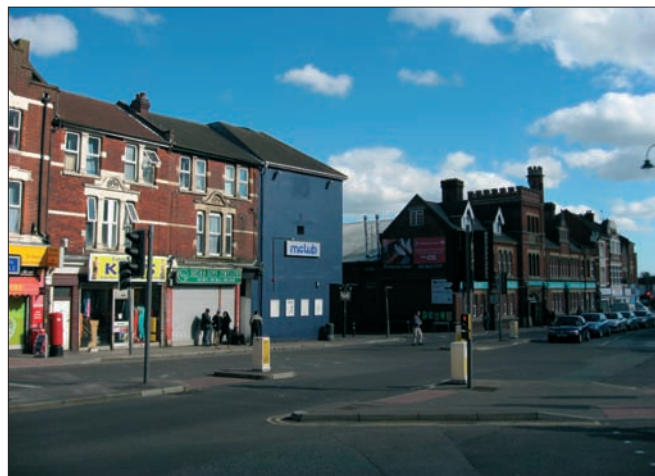
The former drill hall (seen with the crenellated tower) is a memorable building in the townscape

- This road has a high degree of architectural quality despite being in a very poor state of repair and with much alteration to ground floor shops and to windows.
- The former Drill Hall is a striking building in the street scene with its crenellated tower forming a strong central feature in the facade.

- Much needed improvements to the design and material quality for shopfronts and signage.
